COMMON CAUSES OF ELECTRIC IN-TANK FUEL PUMP FAILURES

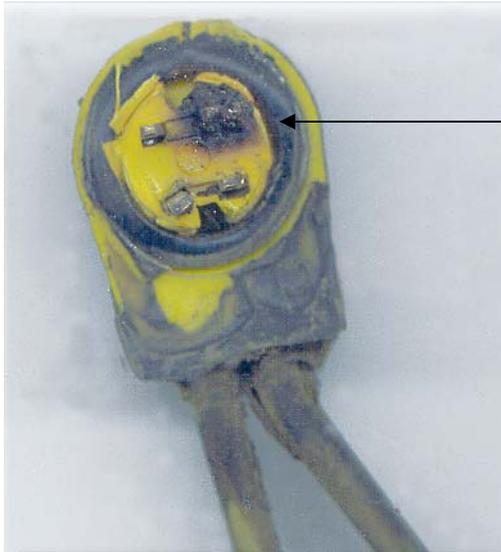
The most common failure mode will be complete loss of continuity on most Chrysler applications. Some may have partial continuity loss, creating an excessive voltage drop. The pump will be energized, but not enough to fuel the system. Always inspect the electrical connections on the outside of the fuel pump hanger assembly and on the hanger to the fuel pump itself. If there is any evidence of a black sooty deposit, melted wires/connectors or eroded connector pins, the connector must be replaced.

This terminal is on the underside of the connector attached to the hanger cover. Notice the black soot, evidence of arcing, at this terminal

An overheated electrical connector

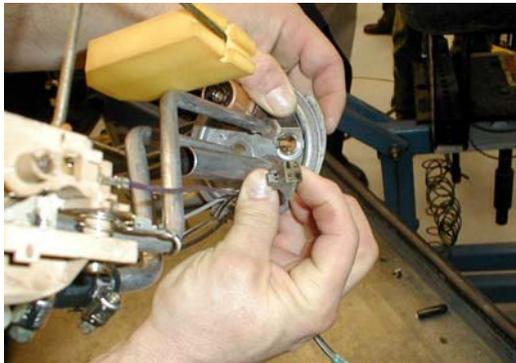
On GM applications from the mid-1980s to late 1990s the most common failure mode of electrical connections is a partial loss of continuity. In some cases a total loss of continuity may occur. An inspection of the connector between the pump and the underside of the hanger must be made. If there is any evidence of a black sooty deposit, melted wires/connectors or eroded connector pins, the connector must be replaced.

Inspecting the hanger wire connections

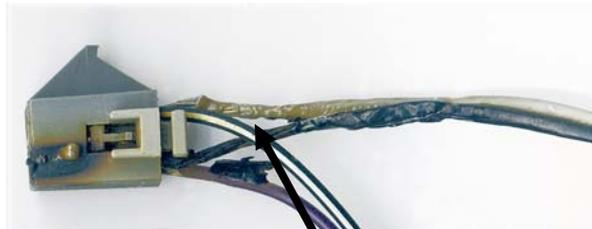
Notice wire insulation is only melted close to connector

Melted connector caused by heat generated from arcing at connection
